Monitoring Data Record

Project Title: US 70 in Salisbury (R-2911E) COE Action ID: 200221536
Stream Name: Setman Branch DWQ Number: 030908
City, County and other Location Information: Salisbury, Rowan Co., Sta. 8+35 to Sta. 8+85
Date Construction Completed: Water was turned and streambank reforestation was completed in March 2006. Monitoring Year: (4) of 5
Ecoregion: _____ 8 digit HUC unit 03040102
USGS Quad Name and Coordinates: _____

Setman Branch

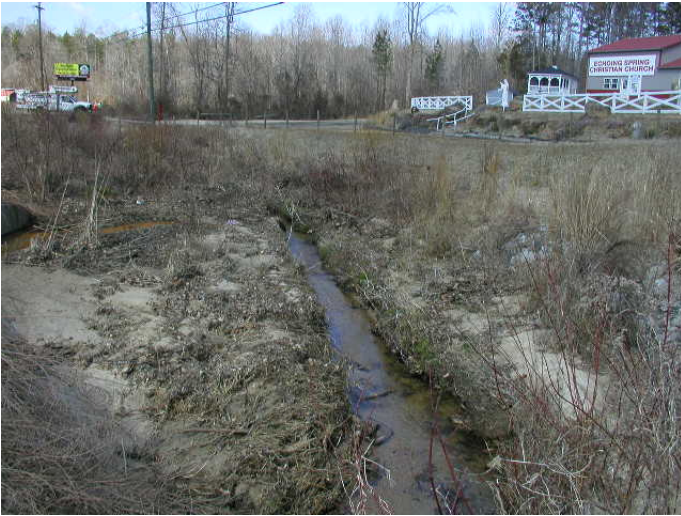
PP#1 (Looking downstream from box culvert)

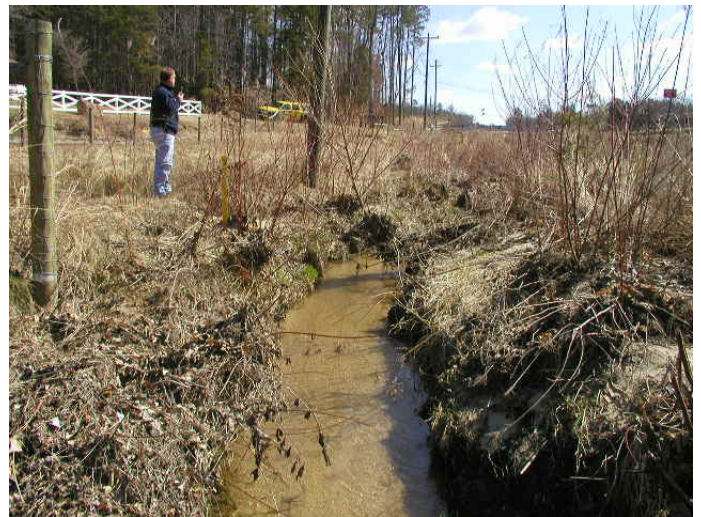
PP#3 (Looking upstream from driveway pipe)
